# Manhole Inspection Summary

Manhole # S11MM\_051MH

Insp Date: **8/29/07 4:11 PM**

**Location** Address: **LONGWOOD ST**

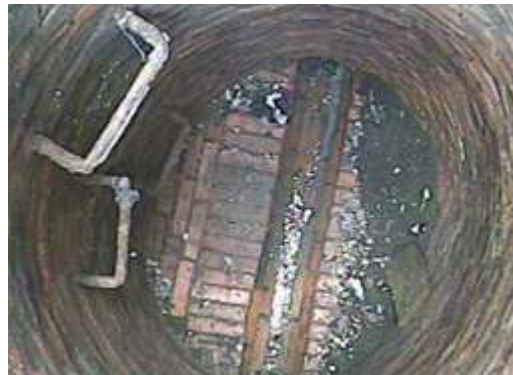
Defect 2

**Steps** Count: **4** Missing: **0** ☒ **Corroded**

CORRODED STEPS

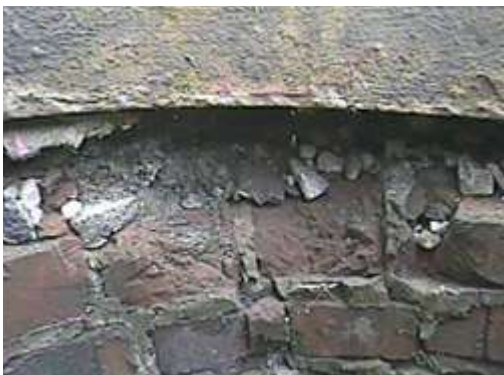
Defect 1

Condition: ☐ Sound ☒ **Cracked** ☐ Root Intrusion ☒ **Loose Brick** ☒ **Deteriorated**

LOOSE BRICKS, DETERIORATED AND CRACKED/ ADJ.

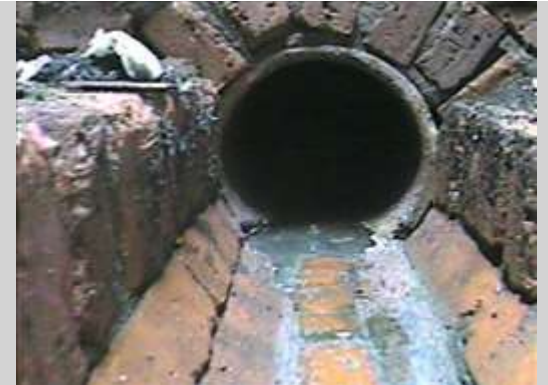
12 O'Clock Outflow

8 in. Circular Gravity Sewer  
Pipe Out @ 12 O'Clock

Pipe Height: (in.) Direct  
Pipe Material: **Clay** ☐ Pipe Lined  
Invert Depth: **8.32** (ft.) Flow Characteristics: **Slow**  
Deposits: ☒ None ☐ Mud ☐ Sludge ☐ Debris ☐ Grease  
Silt Depth: (in.) Deposits Extent:  
Infiltration: **None** Pipe Seal Cond: **Sound**

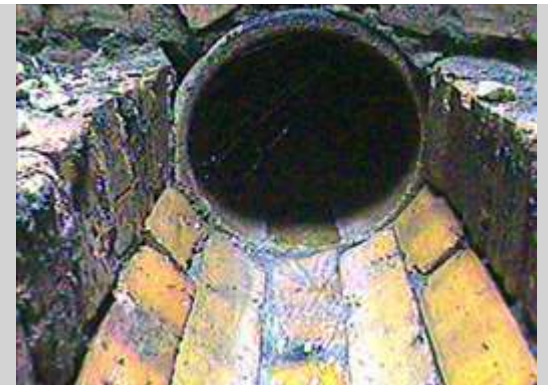
6 O'Clock Inflow

8 in. Circular Gravity Sewer  
Pipe In @ 6 O'Clock

Pipe Height: (in.) Direct  
Pipe Material: **Clay** ☐ Pipe Lined  
Invert Depth: **8.18** (ft.) Flow Characteristics: **Slow**  
Deposits: ☒ None ☐ Mud ☐ Sludge ☐ Debris ☐ Grease  
Silt Depth: (in.) Deposits Extent:  
Infiltration: **None** Pipe Seal Cond: **Sound**
